LYNCHWOOD LAKE DAM

NDI ID NO. PA-00773  
DER ID NO. 45-38

PHASE I INSPECTION REPORT  
NATIONAL DAM INSPECTION PROGRAM

JANUARY 1980

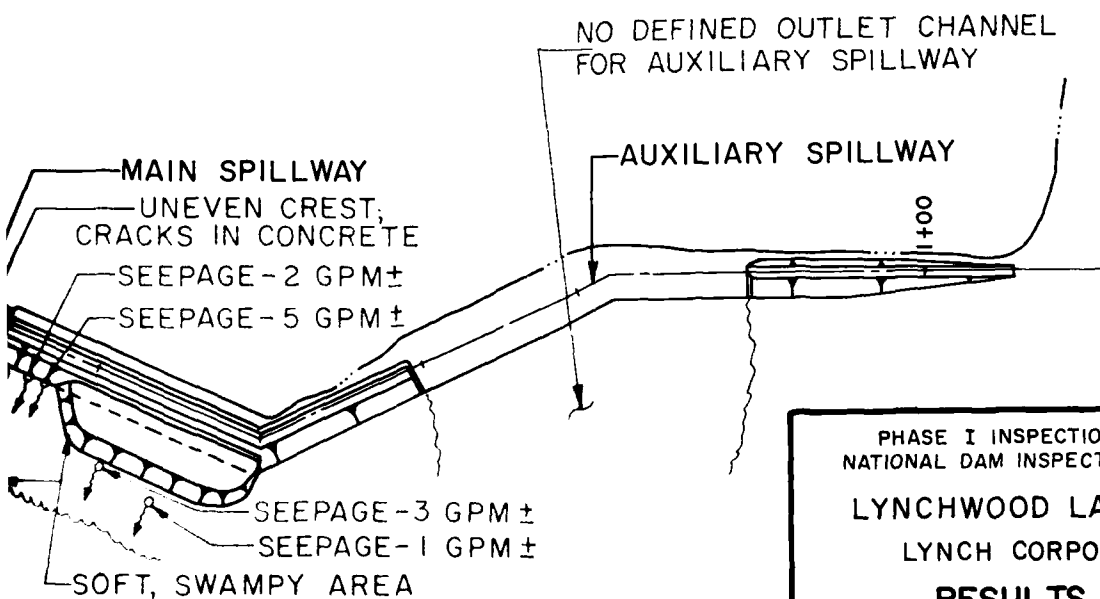
Clear seepage was observed at 10 locations along or near the downstream toe of the dam, particularly in the vicinity of the maximum section. The locations of the seepage areas and the approximate quantities of seepage are shown on Exhibit B-1. Several soft, wet areas were also located along or near the toe. The locations of those areas are also shown on Exhibit B-1.

ALL OBSERVED SEEPAGE WAS CLEAR.
